# Manhole Inspection Summary

Manhole # S53M\_\_019MH

Insp Date: **9/14/09 11:52 AM**

**Location** Address: **3025 Hudson St.**

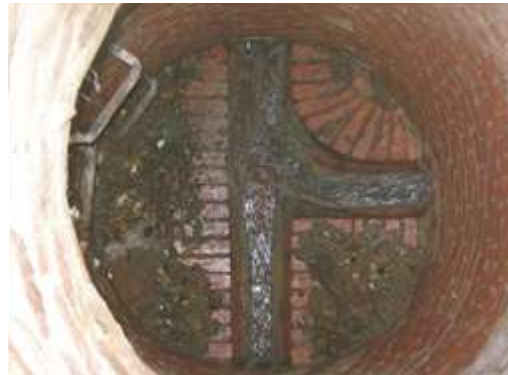
Top View

View facing north

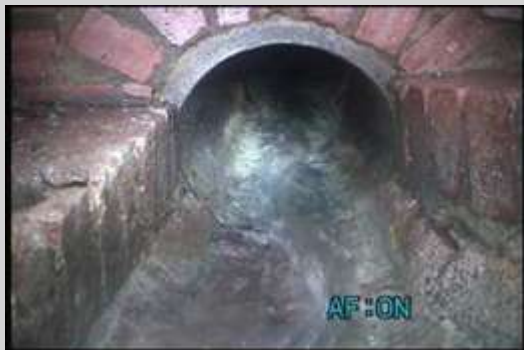
12 O'Clock Outflow

8 in. Circular Gravity Sewer  
Pipe Out @ 12 O'Clock

Pipe Height: **8.4** (in.) Rod and Bar (Angled)  
Pipe Material: **Clay** ☐ Pipe Lined  
Invert Depth: **10.60** (ft.) Flow Characteristics: **Slow**  
Deposits: ☒ None ☐ Mud ☐ Sludge ☐ Debris ☐ Grease  
Silt Depth: **0** (in.) Deposits Extent:  
Infiltration: **None** Pipe Seal Cond: **Sound**

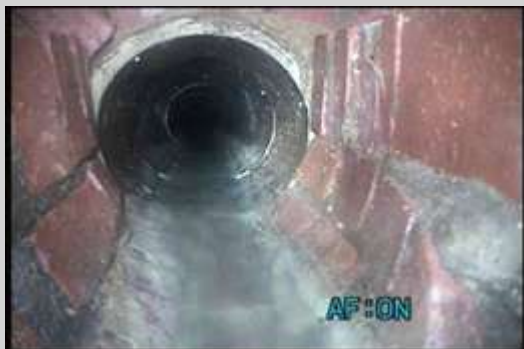
3 O'Clock Inflow

8 in. Circular Gravity Sewer  
Pipe In @ 3 O'Clock

Pipe Height: **8.4** (in.) Rod and Bar (Angled)  
Pipe Material: **Clay** ☐ Pipe Lined  
Invert Depth: **10.10** (ft.) Flow Characteristics: **Slow**  
Deposits: ☒ None ☐ Mud ☐ Sludge ☐ Debris ☐ Grease  
Silt Depth: **0** (in.) Deposits Extent:  
Infiltration: **None** Pipe Seal Cond: **Sound**

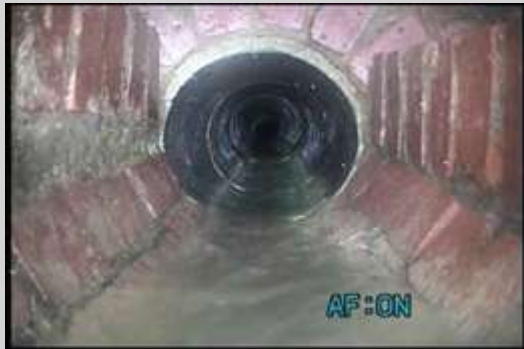
6 O'Clock Inflow

8 in. Circular Gravity Sewer

Pipe In @ 6 O'Clock

Pipe Height: **8.4** (in.) Rod and Bar (Angled)

Infiltration: **None** Pipe Seal Cond: **Sound**
